Engineering Geological Investigations of Two North Canterbury Landslide Complexes.

A thesis
submitted in partial fulfilment
of the requirements for the Degree
of
Master of Science in Engineering Geology
at the
University of Canterbury
by
T. Richard Justice

University of Canterbury
1994

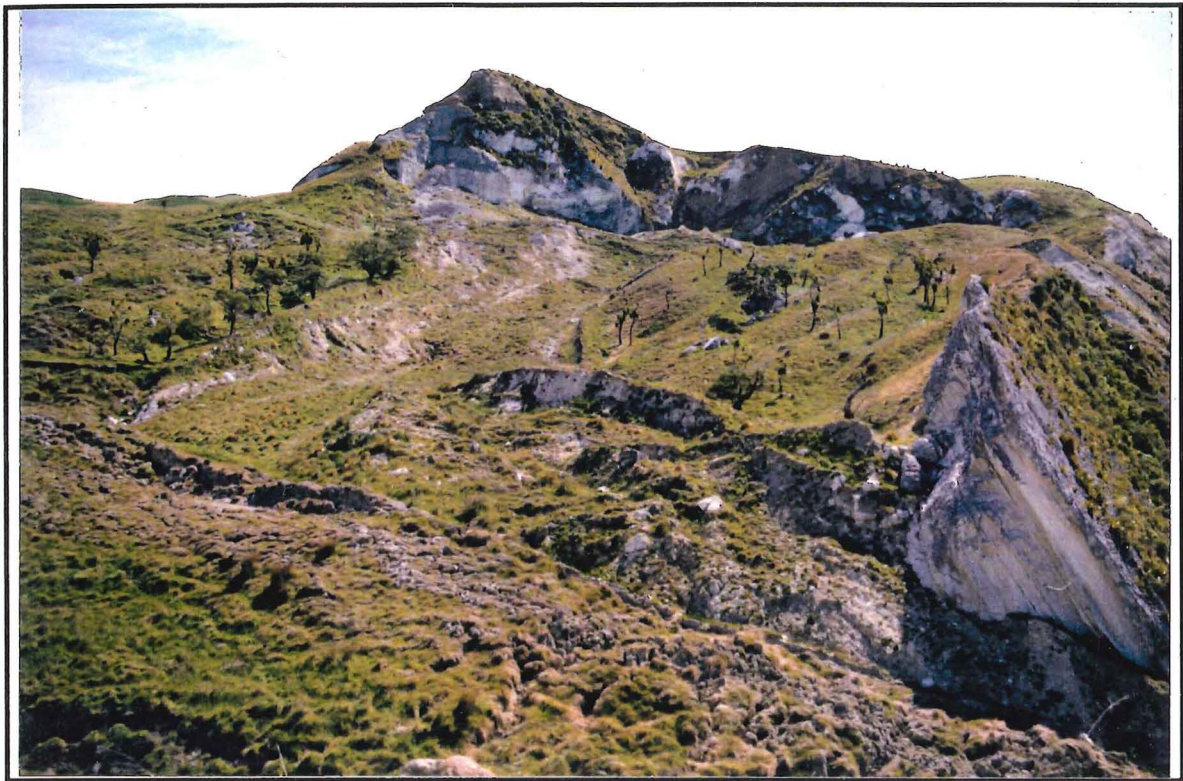
Figure 2.4. View of part of Earthslide A (bottom of photograph; note concave downslope tension cracks); (A) front tilted toe block (note characteristic overstepping of bedding) and; (B) feeder earthslide near toe of complex. View looking approximately east from centre of complex

12. Feeder Earthslides/flows: These features can be observed at various localities (fig. 2.4) and are generally relatively small slides that incorporate clay dominated material into the main body of the landslide complex

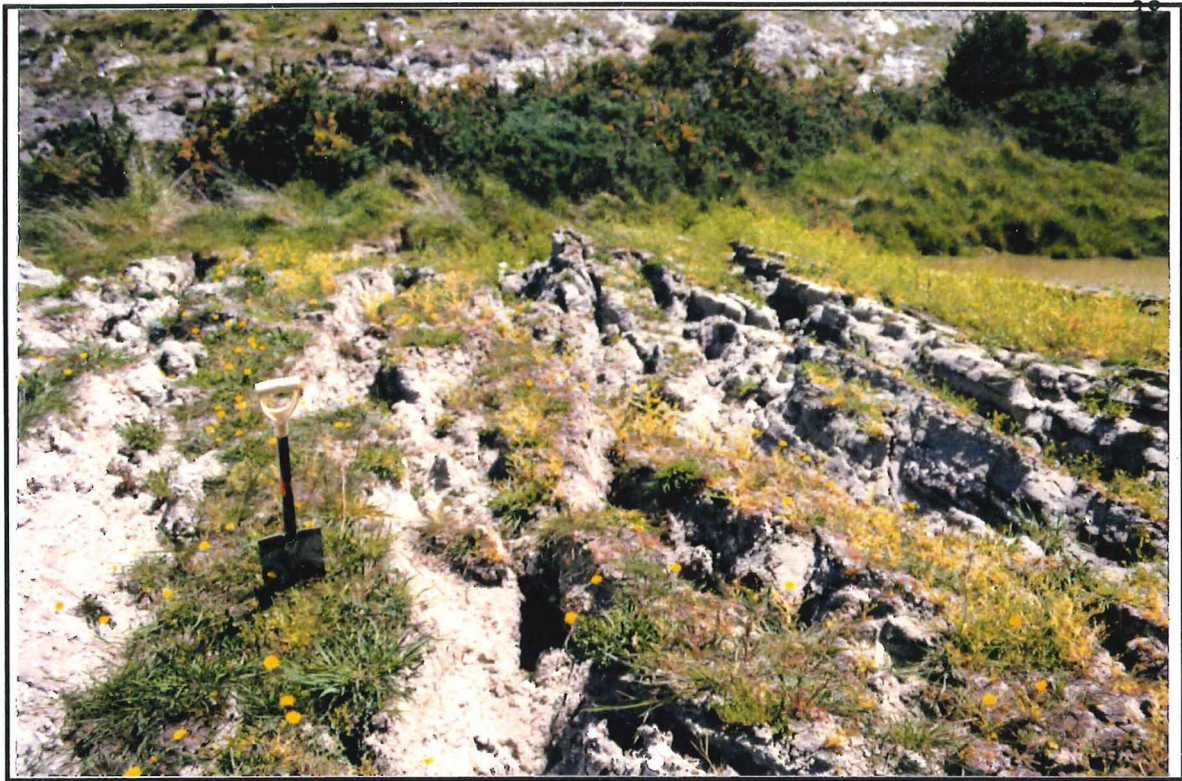
Figure 2.9 Transverse tension cracks, associated with a convex break in slope, Earthslide A, Mt. Vulcan Landslide Complex. Sliding direction left to right.

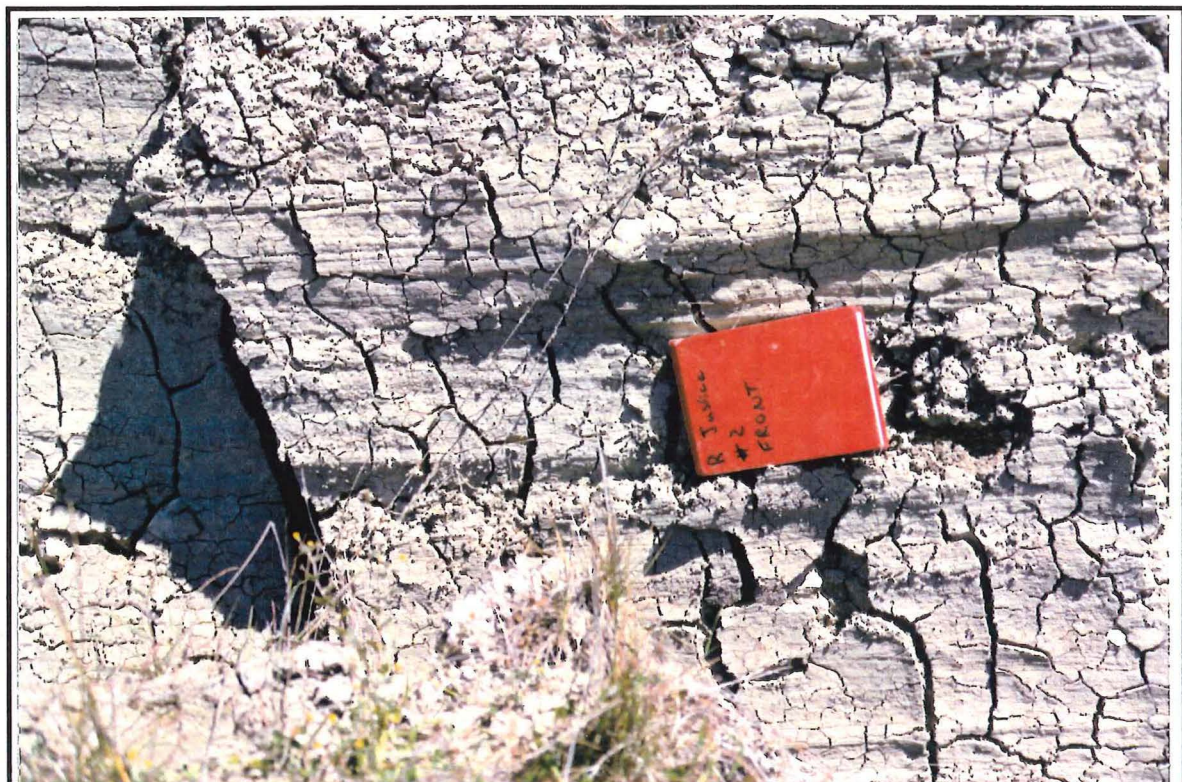
Figure 2.10 Striations and slickensides associated with eastern lateral shear, Earthslide A., Mt. Vulcan Landslide Complex (note shrinkage cracks typically associated with swelling clays). Notebook 18x13cm

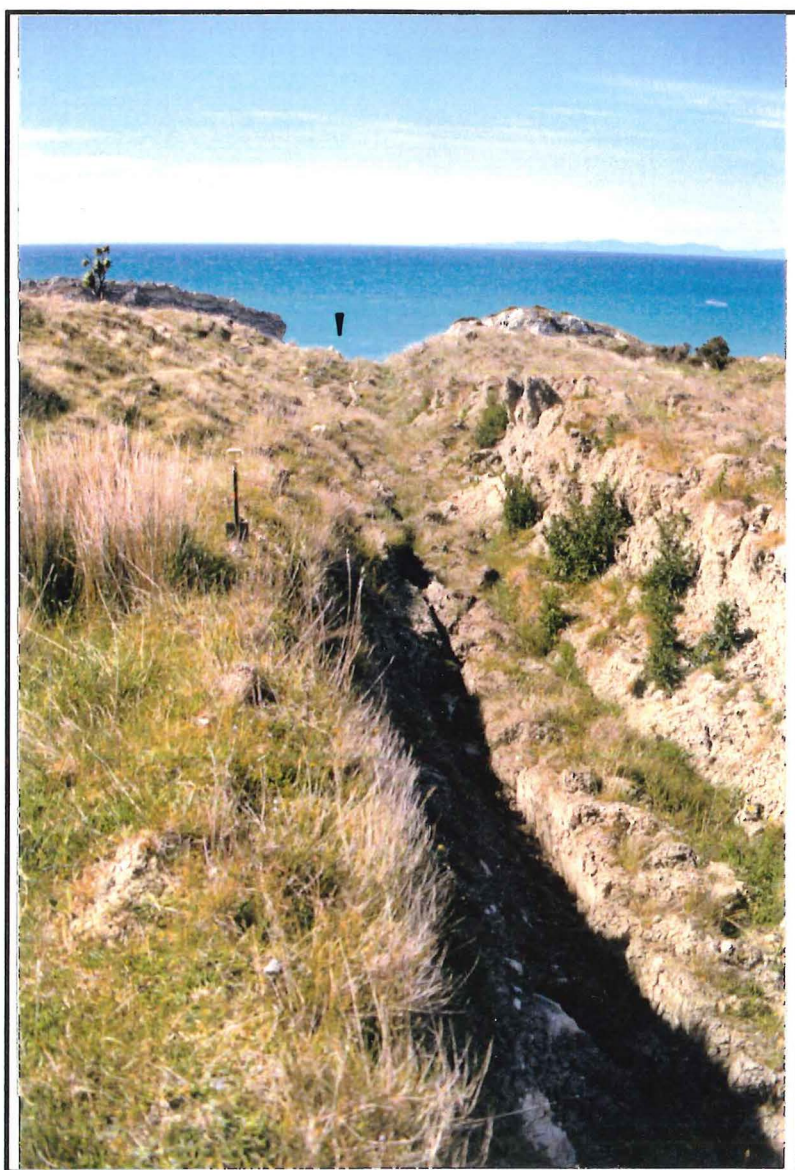
Lateral Bulge

Lateral Shear

Lateral shears bounding Earthslide 3 commonly display slickensides and striations subparallel to the ground surface in the orientation of movement (fig. 2.10). The most common features observed along the lateral shear zone of Earthslide 3 were tension cracks orientated approximately 45° clockwise or anticlockwise respectively from the trend of the underlying dextral or sinistral shear. Tension cracks commonly displayed an en-echelon arrangement. Shear segments along the lateral shear could also be observed, which have the same sense of shear as the main lateral shear, but are turned clockwise or anticlockwise from a few to about 20° from the main shear. Well developed, very linear shears could be noticed at various localities along the boundary of Earthslide 3. In particular, the downslope half of the earthslide was characterised by these well developed linear shears (fig. 2.11). Generally, a saturated zone of about 10 cm in width was associated with these lower lateral shears.

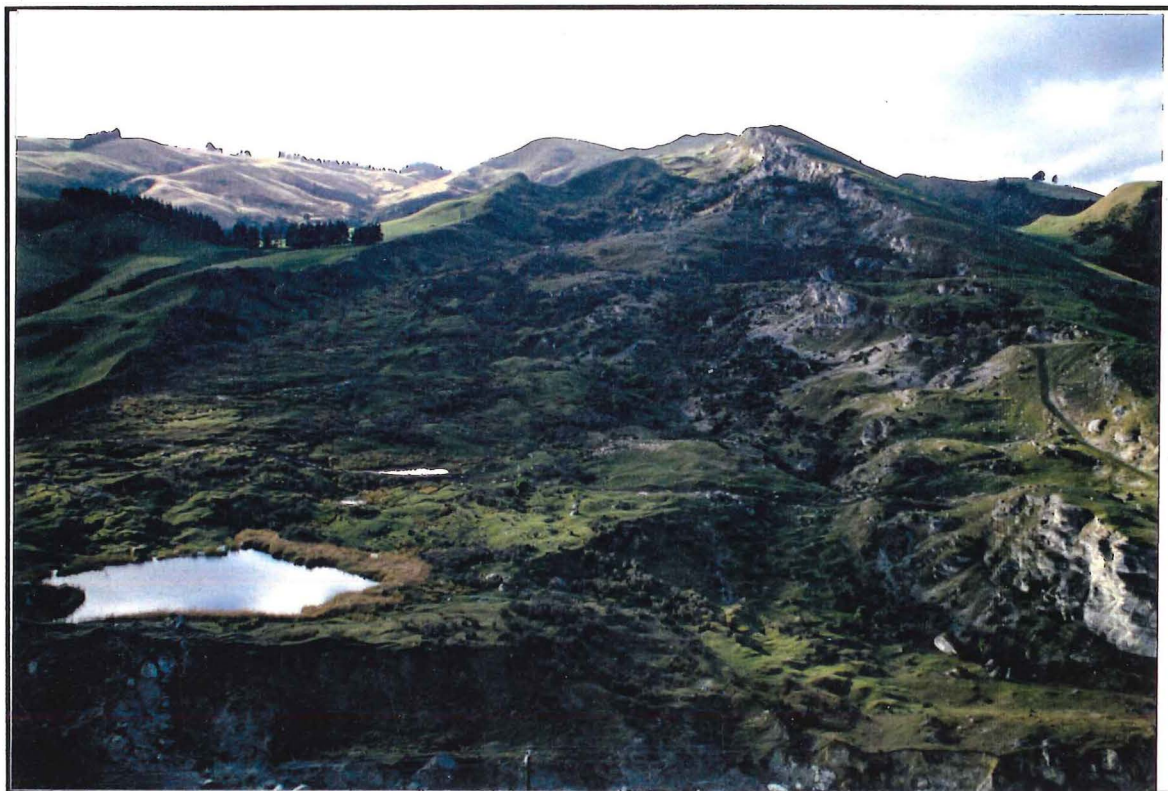
Figure 3.1 Oblique view of Coringa Landslide complex. Photograph looking approximately north.

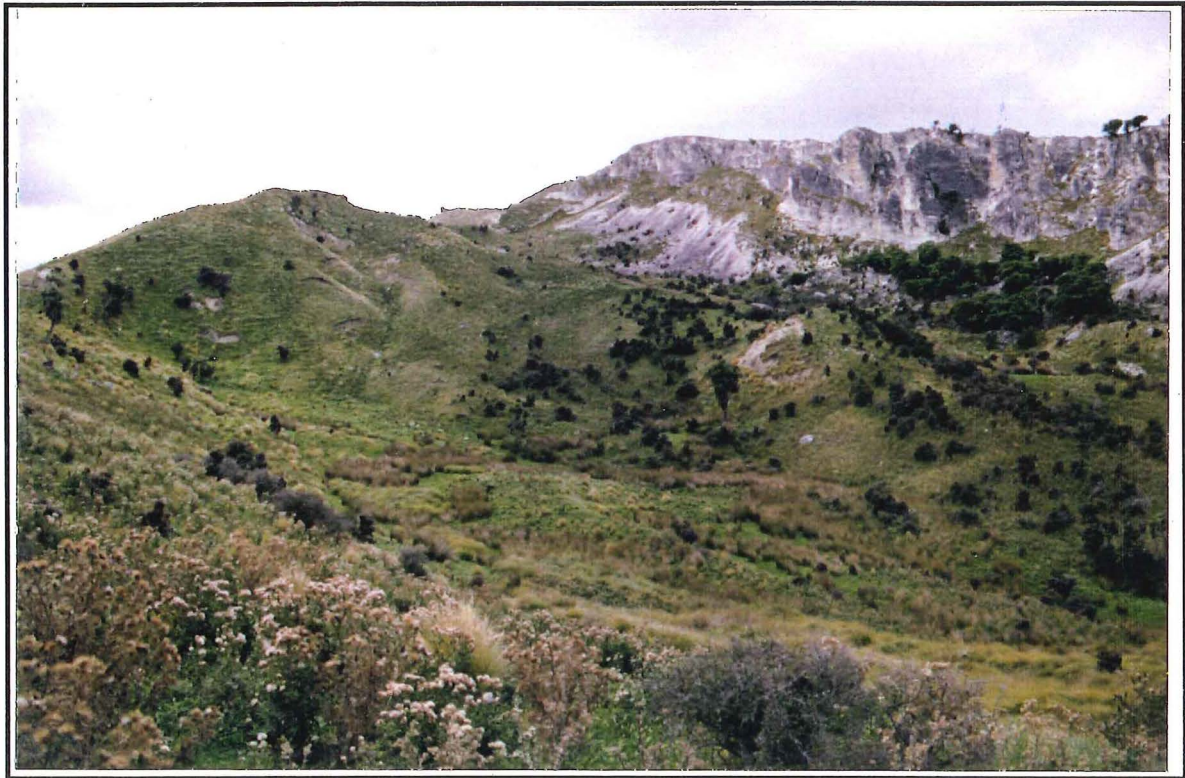
Figure 3.3 (A) View of the head of the eastern lateral scarp (morphological unit 5), (B) Upper basins (unit 4) and (C) slump block (unit 2); taken from western lateral scarp.

5. Eastern Lateral Scarp (fig. 3.3). This prominent scarp has been formed by retrogressive failure of limestone blocks by falling, toppling or sliding. Limestone material is constantly being fed by these failures to talus aprons which conceal the bottom of the scarp.

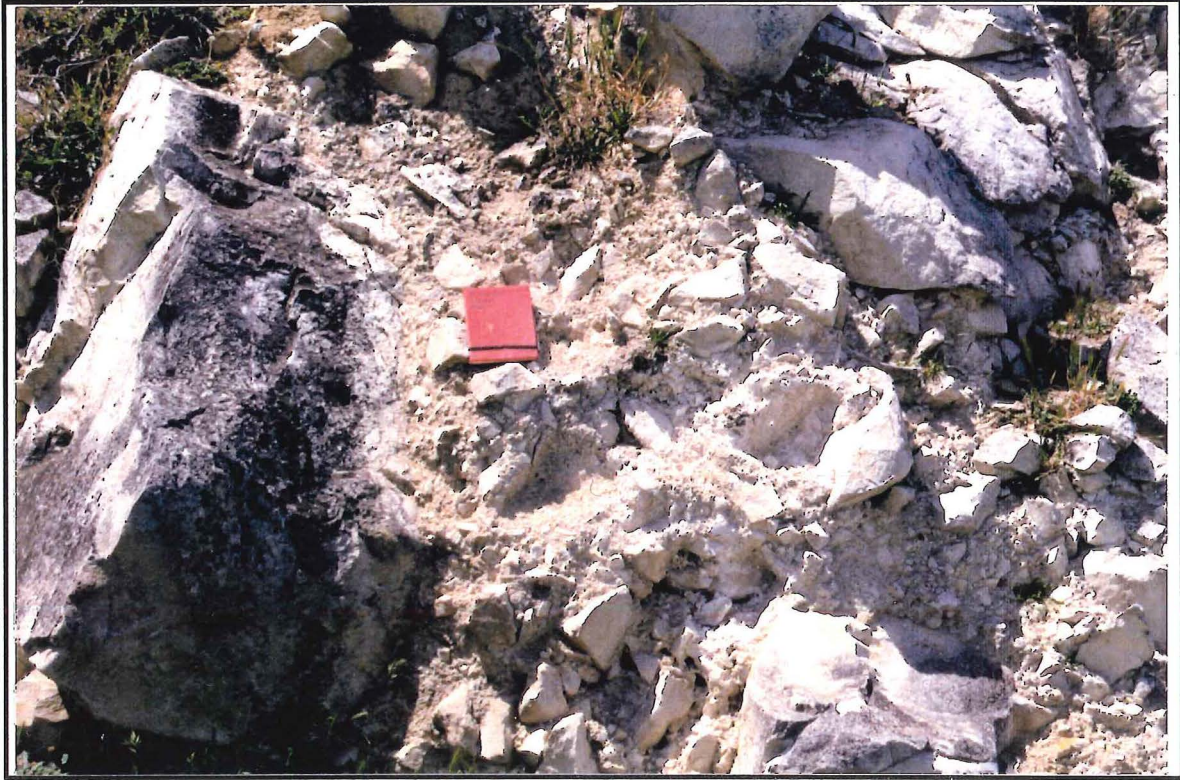
Figure 3.5 Typical disrupted limestone material from slumped block zone (notebook is 18x13cm).

2. Disrupted limestone, which consists of blocks (up to about 5 m diameter) of Amuri Limestone, either internally intact or pervasively fractured (fig. 3.5). Material between blocks is typically fine sand to chaotically arranged angular boulder sized-limestone fragments in a matrix of silty clay. This matrix is generally well graded and clast supported, and typically comprises 25-45% of the soil mass. Disrupted limestone material comprises part of morphological unit 1 (older earthslide/flow debris).

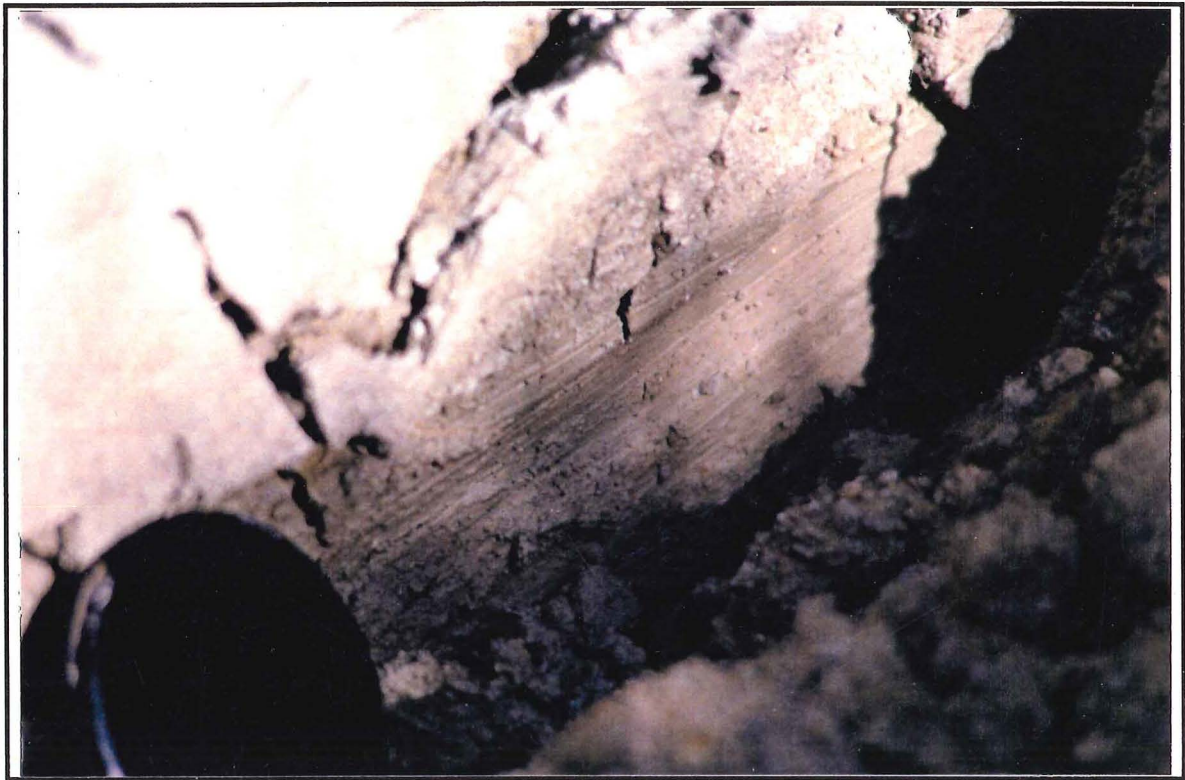
Figure 3.8 Exposed striations and slickensides on eastern lateral shear of Earthslide 3 (lens cap is about 7 cm diameter)

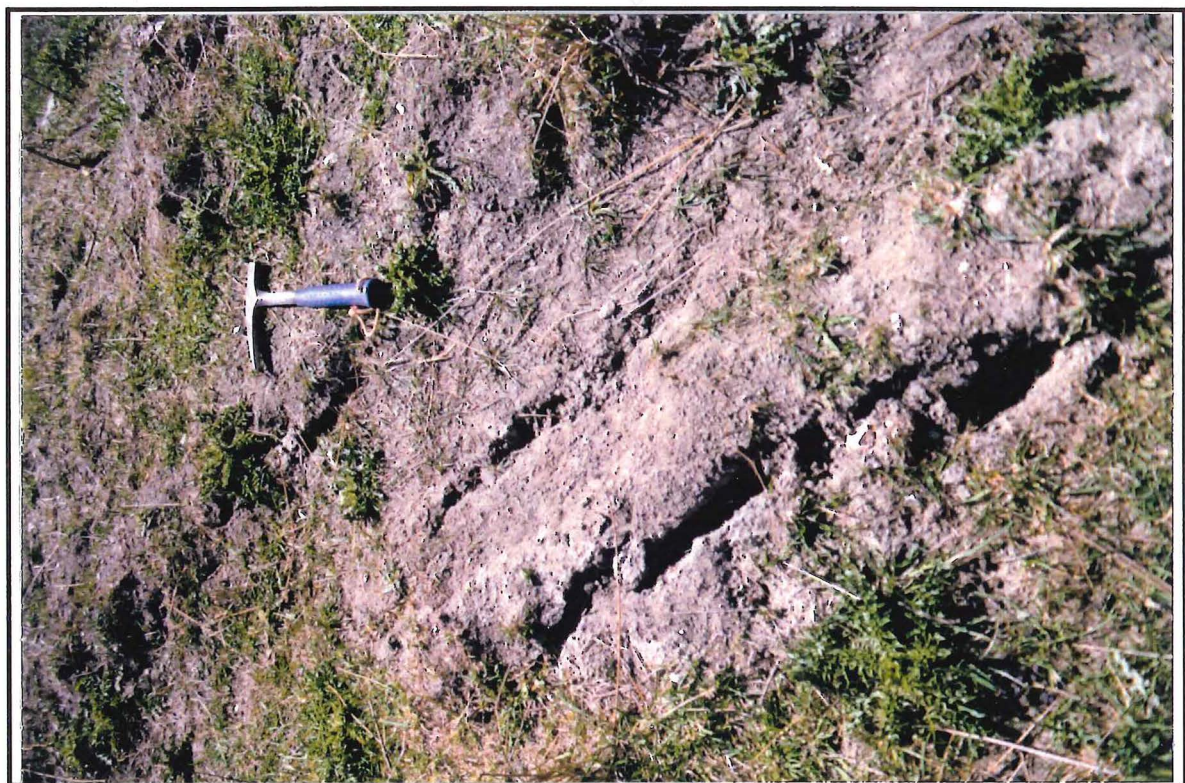
Figure 3.9. En-echelon tension cracks, eastern lateral scarp, Earthslide 3 (bottom of photograph at right of page; hammer is about 30 cm long)

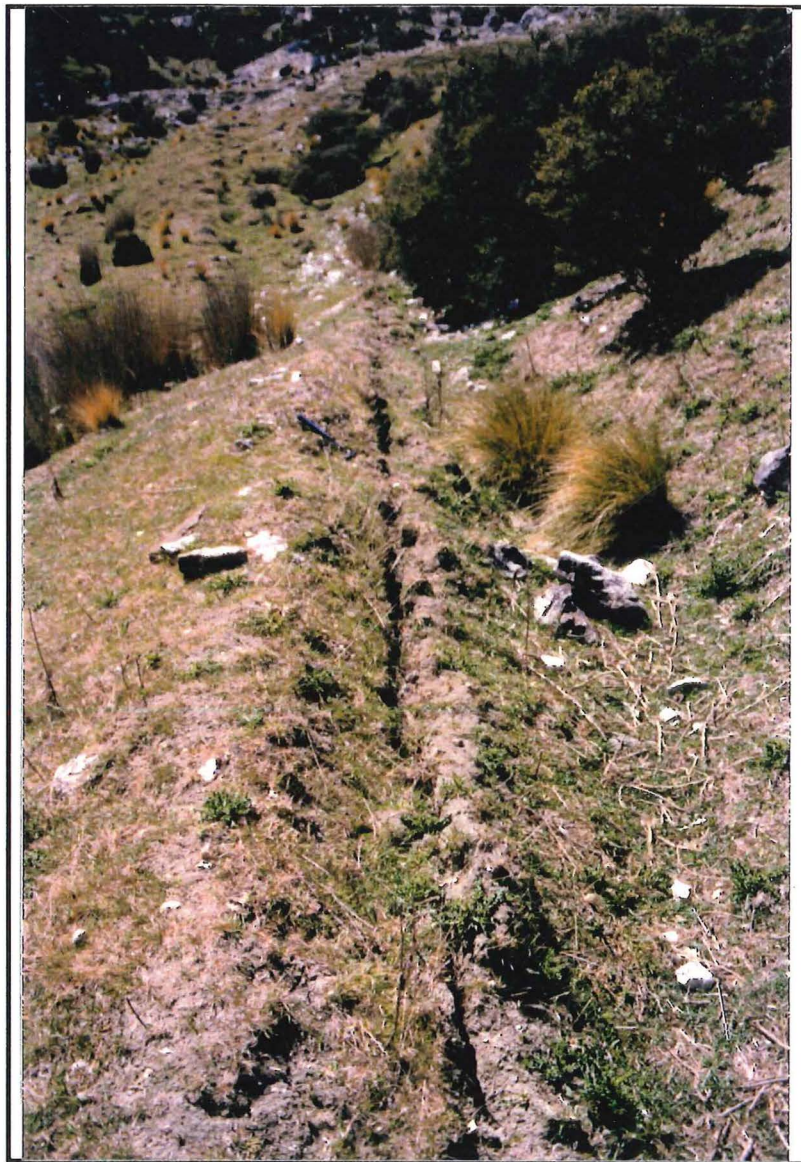
Figure 3.10 Fully developed lateral shear, eastern lateral scarp near the head zone of Earthslide 3.

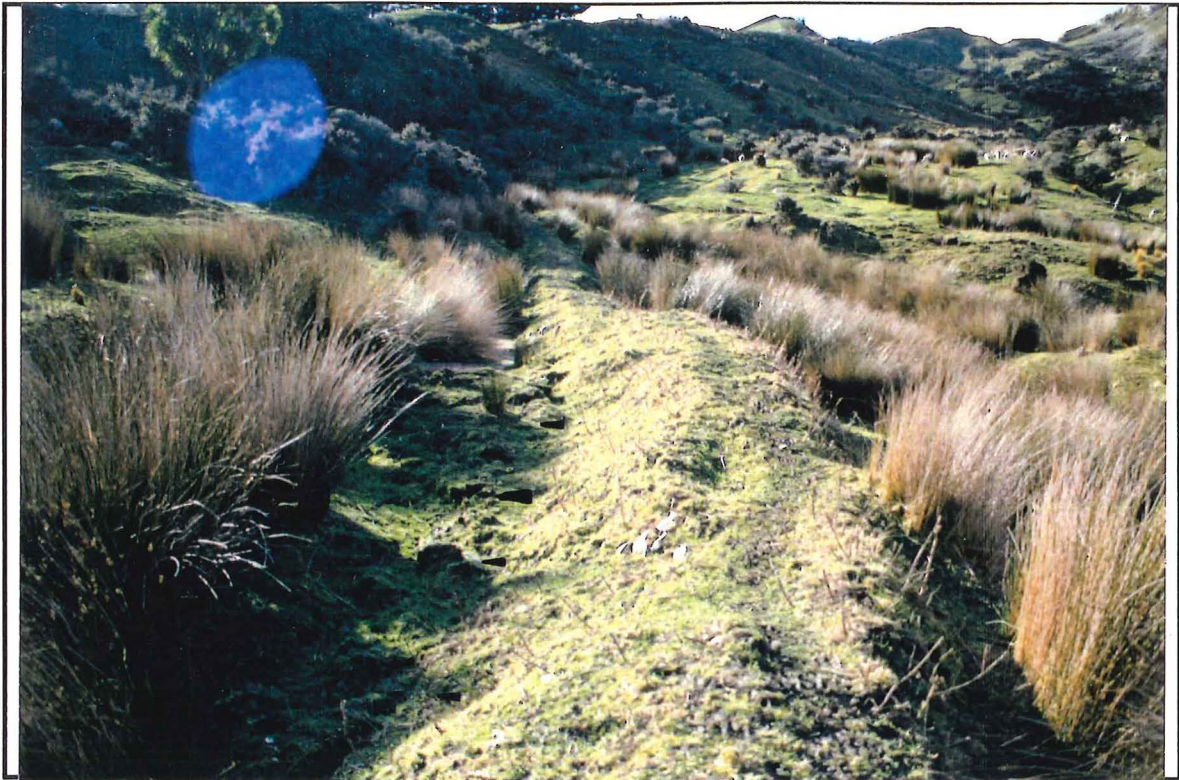
(a) Type I lateral bulge (note lateral shear plane, arrowed, on outside of bulge)

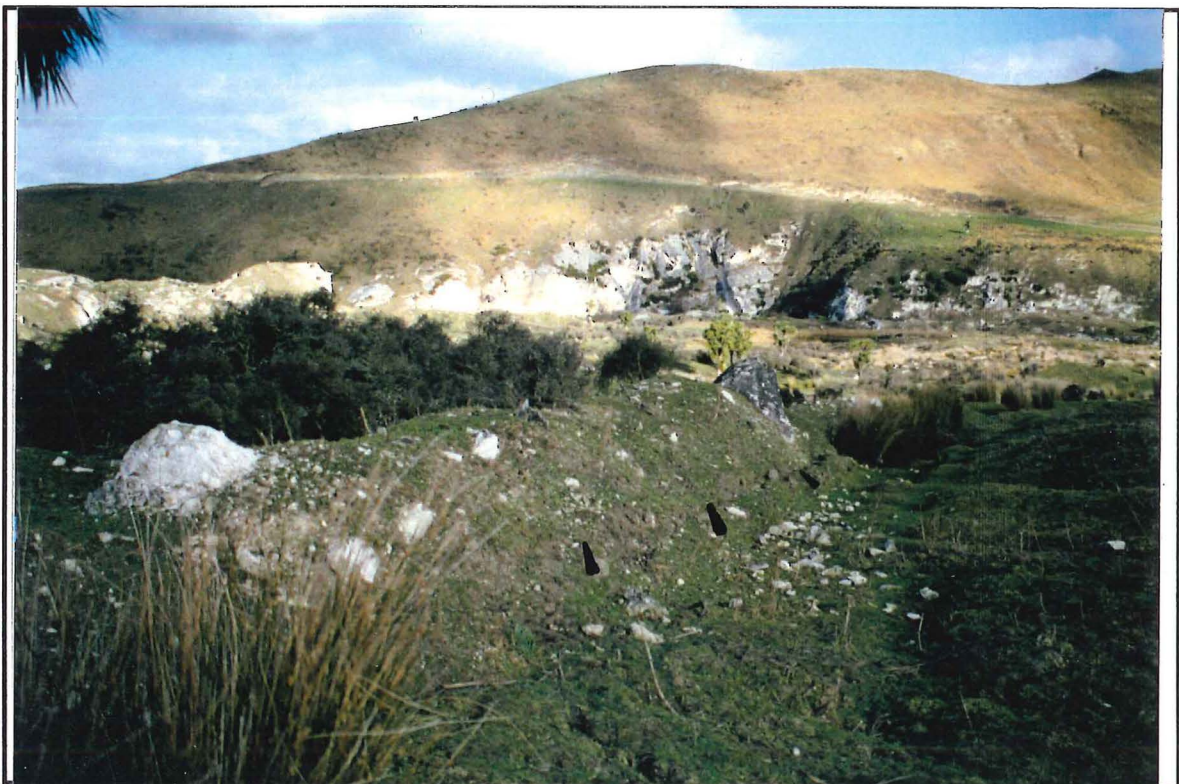
(b) Type II bulge (note lateral shear plane, arrowed, on inside of bulge)
